CASE STUDY

Treatment of Municipal Wastewater Treatment Plant for Hydrogen Sulfide Control with BIOFLOC™ Bacteria Culture

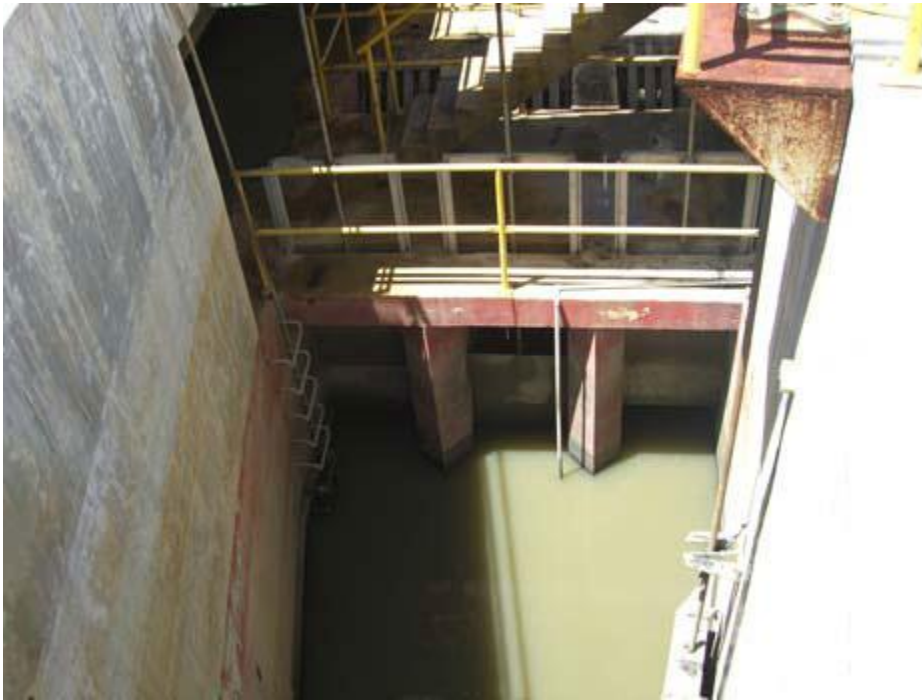
Results: BIOFLOC™ treatment resulted in excellent control of H₂S, reducing the concentration from as high as 500 ppm to less than 1 ppm. H₂S levels began to rise by May 19th, two weeks after the final addition of BIOFLOC™.
